## Avoiding gearbox misalignment issues

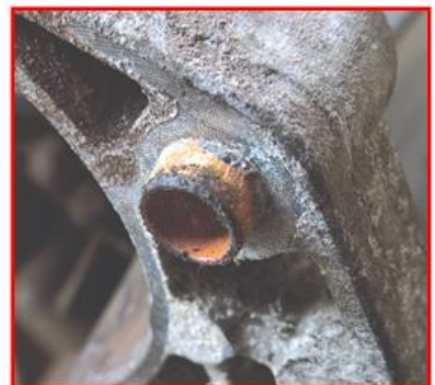
Misalignment is commonly caused by damaged or missing dowels or damaged dowel locating holes between the engine and gearbox, with the result that the engine and gearbox are no longer correctly centralised. All damaged or missing dowels should be replaced with new components. Valeo Service also advise cleaning all dowel pins with an emery cloth in order to ensure they locate correctly into the dowel holes on the gearbox. Clean dowel pins will also prevent the gearbox from seizing which avoid any difficulties when removing the gearbox in the future.

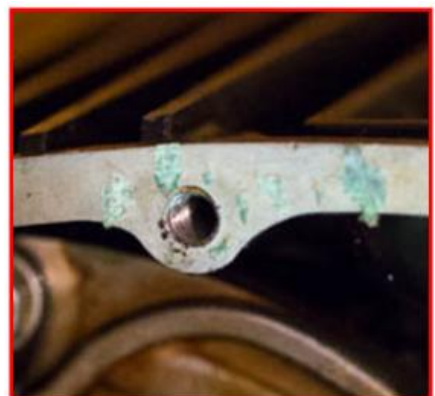
Misalignment can also be caused by bellhousing distortion or cracking, welding repairs to a damaged bellhousing, and engine or gearbox conversions where the adaptor plate or conversion bellhousing has missing or inaccurately-positioned dowel locations. Misalignment can also be caused by failure to clean old hardened dirt or sealant from the mating surfaces of the engine and gearbox flanges before fitting the gearbox. Valeo recommend cleaning the mating surfaces of the gearbox and engine prior to reinstalling the gearbox.

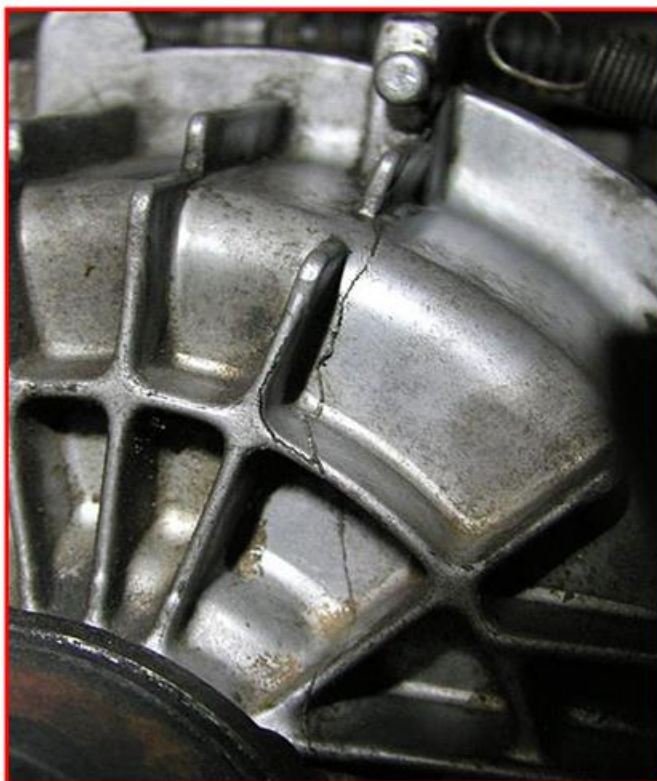
Before fitting a new clutch to a vehicle, the original friction plate should be carefully inspected for evidence of excessive wear or damage to the torsional damper spring(s), spring window, friction washer, hub spline and stop pin wear, and cushion segment failure, which often indicates the presence of a misalignment condition. Misalignment problems should be properly rectified by ensuring that all damaged or missing dowel locating pins or bushes are replaced with new parts and all dowel locating holes are undamaged and clear of debris. A new or undamaged bellhousing should be fitted if the dowel holes are damaged or the bellhousing is cracked or distorted.
