| **Climate control** | Compressor 699357 | Modification pulley | VAG models

## Compressor safe guard modified

### The breakaway device of the pulley has been improved

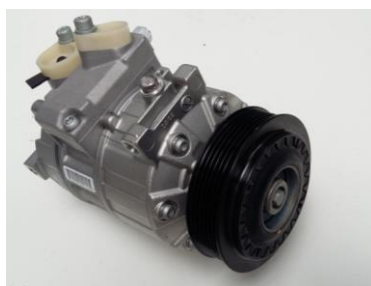
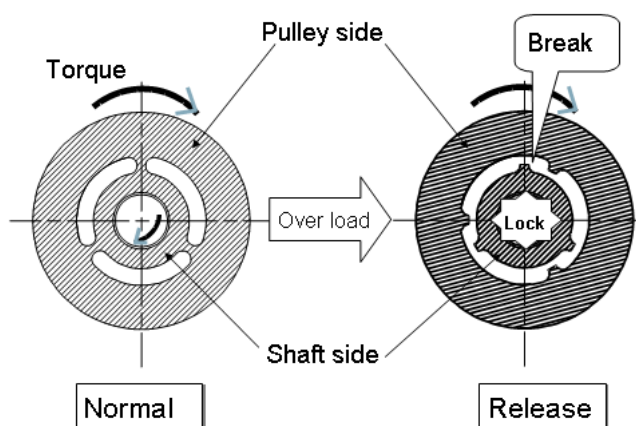
### Old configuration:

- Plastic pulley assembly
- Rubber damper assembly
- Robustness with regard to negative torque about 1,000,000 cycles (20 Hz,  $25 \pm 35$  Nm)

- Decoupling through breakage

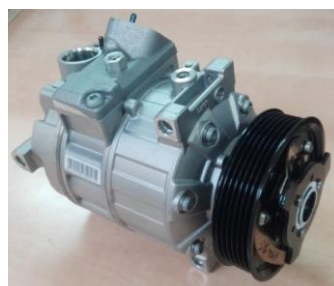
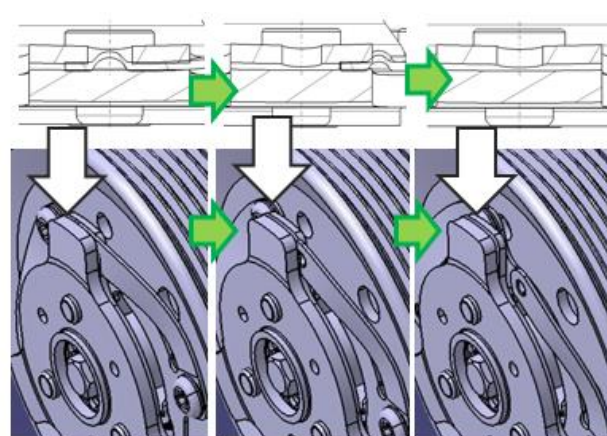
### New configuration:

- Metal pulley assembly
  - Steel "driver" composition
  - Robustness with regard to negative torque about 10,000,000 cycles (20 Hz,  $25 \pm 35$  Nm)
- 10x more!**

- Mechanical decoupling

The solution has been found in using a different pulley / damper assembly; formerly this was a "clutchless" type, where it is now a "driver" type.
