## Heating issues not attributed to the heater matrix

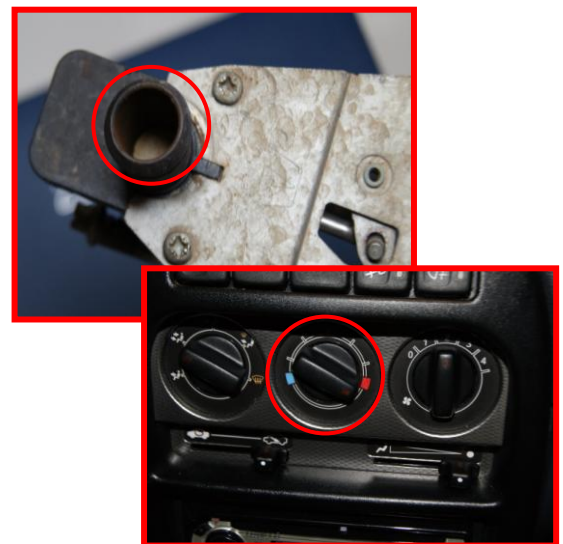
*Ensure valve is opening and closing when heat dial is operated*

**The heater control valve is faulty or mixer flap has failed** - This will give a mis-diagnosis of a faulty heater core but the coolant is not circulating around the matrix or the control flap inside the vent system has failed, causing the circuit that directs air through the heater matrix to remain closed.

If the vehicle is fitted with a heater control valve check it is working correctly by operating the heater dial on the control panel and note if the system is opening and closing fully. If not, adjustment or a new valve will be required. A control flap, due to its location in the ventilation system can be more difficult to test. Some vehicles will require a diagnostic system to ensure the flap is working correctly while others may be able to be checked by visually inspecting the unit and testing whilst removed from its location.

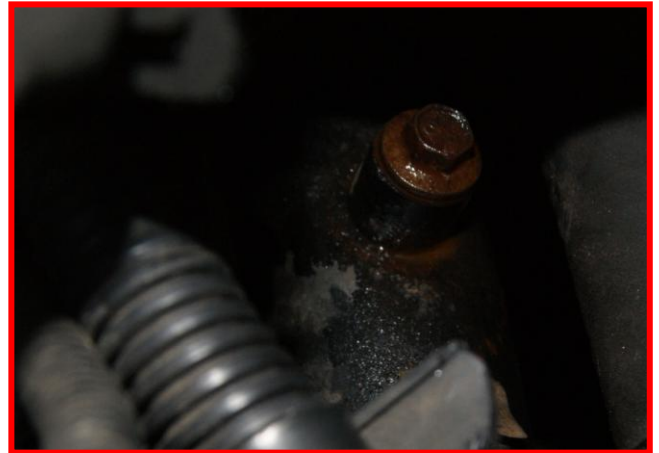
*Bleed valve is found on nearly all vehicle cooling systems. Check manufacturer's guidelines for location*

**Coolant level has dropped or has recently be refreshed** – If the heater matrix has lost performance since a coolant change or coolant was low, the most common reason would be air trapped in the coolant system. To check and eradicate an air lock in the heater circuit, ensure the valve, if fitted, is open then release air by opening the bleed valve. This will be located within the vehicles cooling system, check manufacturer's instructions for location.
