## REPAIR INFO FOR Transmission Systems

**For Vehicle: Chevrolet, Opel, Suzuki and Vauxhall Models  
with an F17 Gearbox**

### COMMON F17 GEARBOX ISSUES NOT ATTRIBUTED TO THE CLUTCH

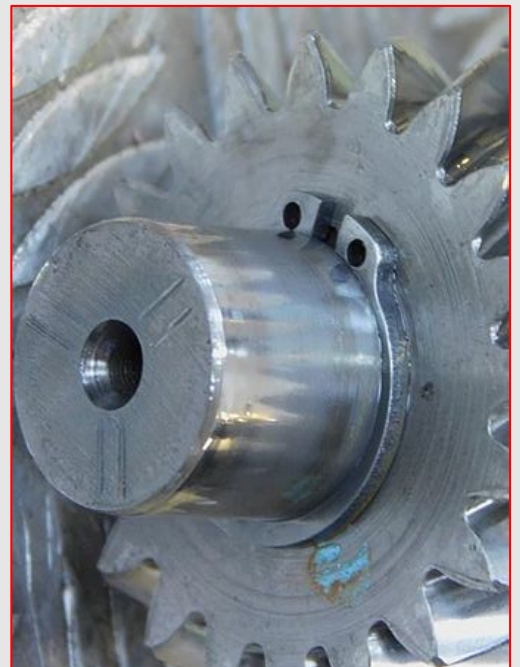
One of the most common issues with the F17 gearbox is bearing wear which can eventually cause complete failure of the gearbox. This issue starts off as a slight whine and can be heard constantly as the vehicle picks up speed regardless of whether the clutch is depressed or not.

This fault is due to the lower output shaft bearing, which when worn, also damages the output shaft itself. Unlike most gearbox designs the bearing runs on the output shaft itself rather than a corresponding outer shell. Unfortunately, this means when wear does occur the output shaft needs repairing or replacing if the damage is too severe. This can drastically increase the price of repair so is often overlooked or not regarded a priority. If the output shaft or bearings are not repaired or replaced, it will eventually result in major failure, including the collapsed bearing breaking through the inner bell housing. This means that a complete gearbox replacement is then required rather than just a bearing rebuild.

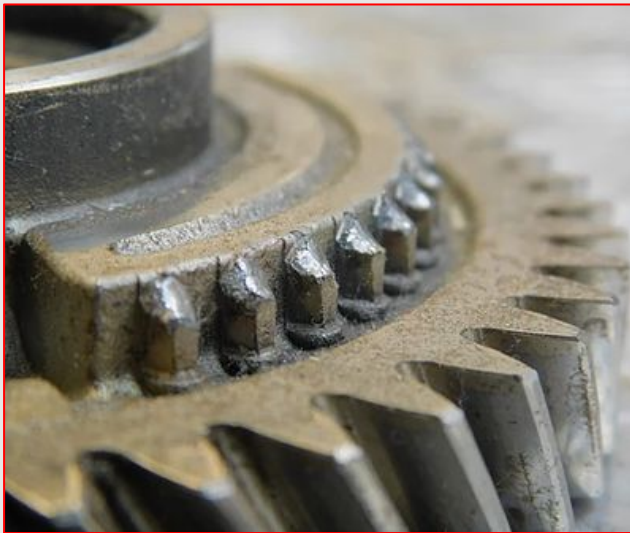
distinguished by when the grinding sound is produced. Synchromesh issues will produce an audible noise only as the gear is being selected, either on upshift or downshift. Bearing failure noises maybe constant in all gears or constant in certain gears when driving. Once the synchromesh is worn, it fails to stop the gear from spinning and allows the hub ring to come down on a moving part. This results in the grinding noise as two metal parts come together. This contact between moving parts results in the edge of the selection teeth on the gear and hub ring to wear down slightly each time. This can be seen in the image below.

If the gear wheel is not replaced, eventually there will be not enough tolerance left on the gear teeth to hold the hub ring on the gear and the torsional force results in the ring popping out and de-selecting of the gear. The vehicle driver will then experience sudden loss of power and over-revving of the engine as if the clutch has been engaged.

It should also be noted, metal particles from the gear and hub can also prematurely wear other components, especially bearings. This may result in more damage as the particles float around in the gearbox.

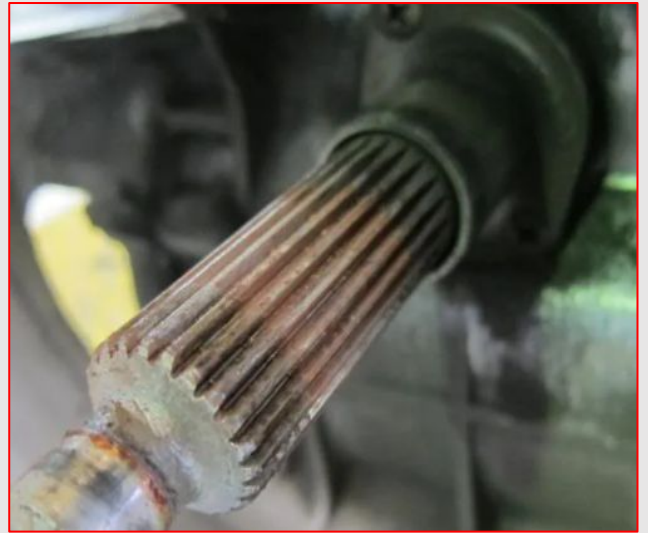
Another common failure on the F17 gearbox is the lack of lubrication to the gearbox input shaft. The clutch friction plate must be able to sufficiently slide back and forth along the input shaft in order to ensure a smooth gear change.

If the gearbox input shaft splines are not sufficiently lubricated they will eventually dry out and/or tribocorrosion will occur. This will result in shifting between gear getting progressively worse, particularly downshifting as it increases the friction between the friction plate and input shaft.

Vauxhall have released their own communication regarding the importance of ensuring that the gearbox input shaft has been sufficiently lubricated.

**Valeo advise checking all components in the transmission system before attempting to refit another clutch kit. Root cause diagnosis should be performed to identify the cause of the failure or the symptoms being experienced.**
