## Technical Bulletin

### Compressor

## A/C LOOP FLUSH AFTER COMPRESSOR FAILURE

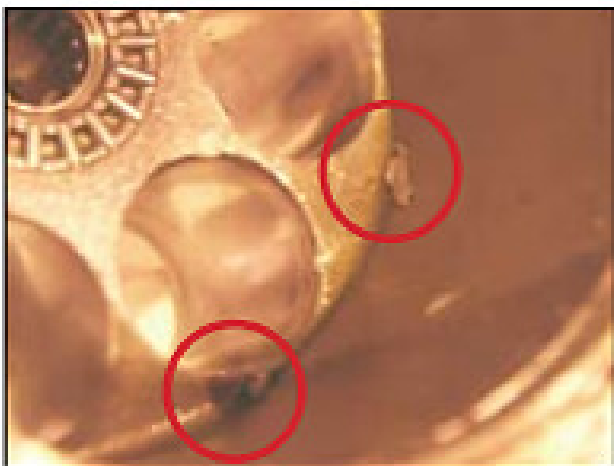
Example of damage found to a compressor which suffered a premature failure due to particles inside the A/C system.

*Particles found in casing*

The A/C system must be thoroughly flushed in the event of a compressor failure to prevent particles remaining inside the A/C loop. Rapid catastrophic failure of the new compressor will occur if a flush of the system is not carried out. Removing and cleaning individual components from the system will not be sufficient. Only flushing the system using appropriate equipment (available as an option for Valeo ClimFill unit, P/N 699955) which has been connected into the A/C loop will sufficiently eradicate damaging particles. A clean A/C system is most important for the system to remain functioning perfectly and efficiently

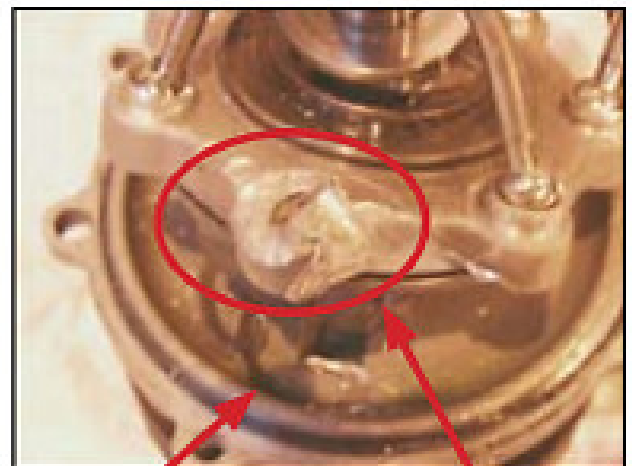
*Damaged piston rings*

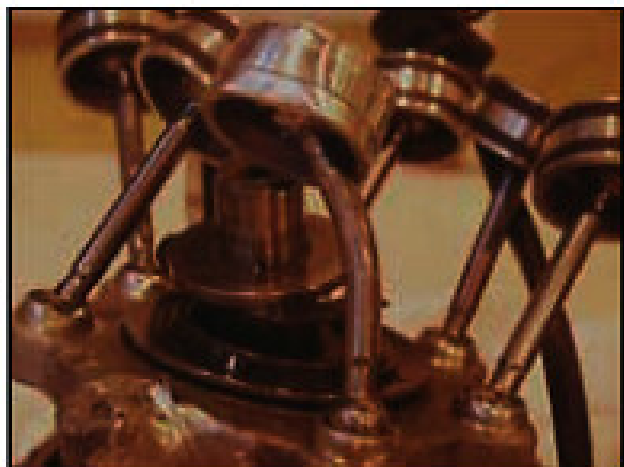
*Damage to scroll plate*

*Additional piston damage*

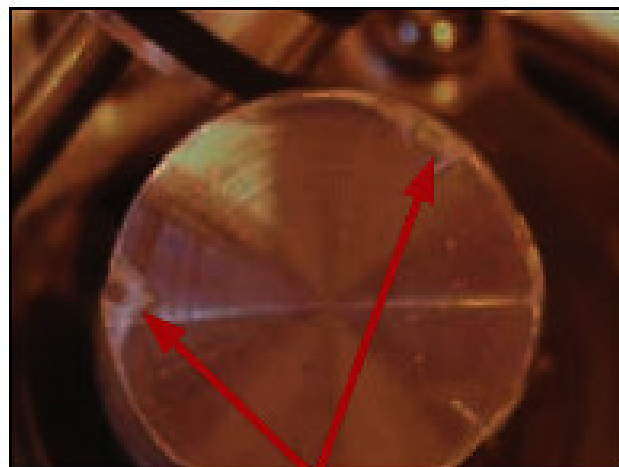
*Damage to piston crown*
